Project Title 2022 Initial Building Survey

Action Item
Building Survey of the Elvehjem Arts Building

2022 ABC Midwest Solutions Building HVAC Equipment
and System Survey

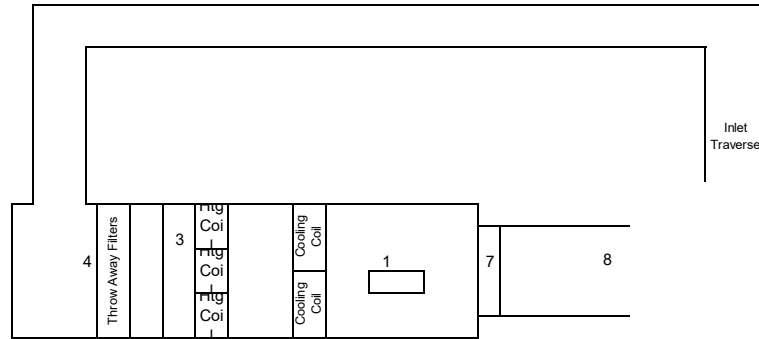
AHU 1

1 Air Handling Unit	UW Asset Number	UW PM Number
AHU # 1	111515	0554-019B
Detailed Summary	The housing is from the 1988. It was found to have its original motor and is warm to the touch. The blowers appear to be in great shape. I'm not sure what is going on with the age of the bearings. The inlet air control dampers do not exist on this unit. It just recirculates the air. Serves the perimeter skylights. The unit is shown moving too much air volume in the 1990 air balance survey.	
	1 2022 Action Item	UW Safety Bearing Exposure and Excessive grease The blower bearings are exposed and could hurt someone if were to

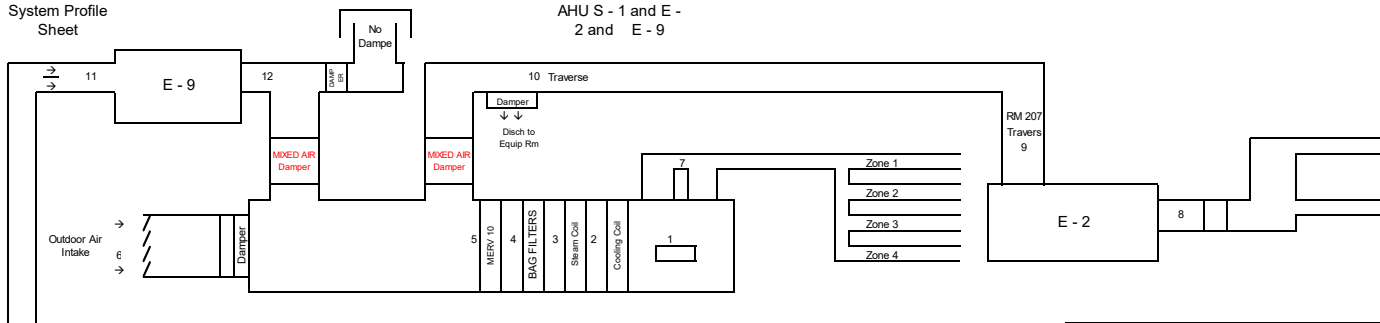
Interlocked with E-2 and E-9 (Return Fans)

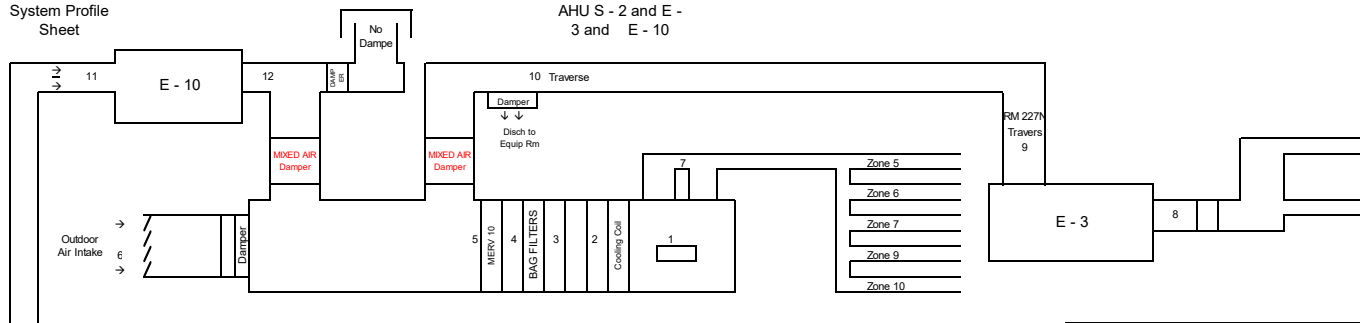
Interlocked with E-3 and E-10 (Return Fans)
