**Testing and Balancing Report for
The Bar on the Ridge
623 Main Street
Ridgeway, WI 53582
1-608-284-0399**

Date	1/10/2025
Building Name	Emergency Kitchen EF Issue
Building Number	NA
ABC Work Order #	0984
Phase	011

Contact Person	Sara Brewers
Action Item	A bar had its cooking hood cleaned and the fan that serves it became "too unstable". We were asked to investigate the issue and solve it so the customer could use it for the Friday Night Fish Fry in the next day or so.

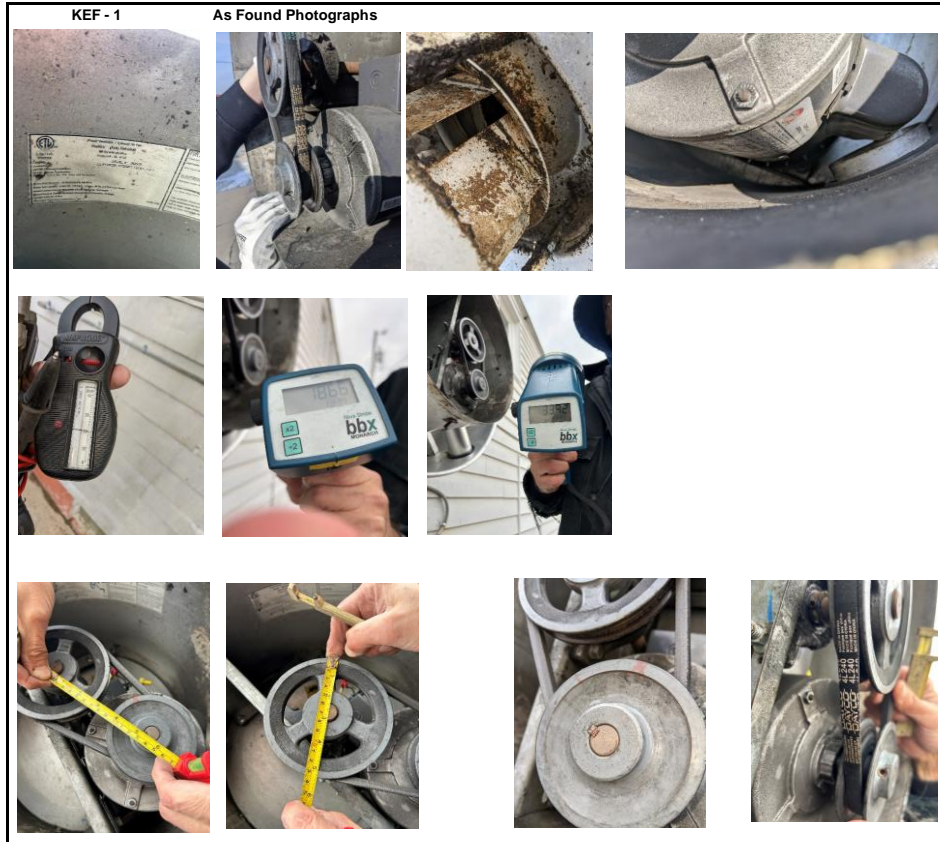
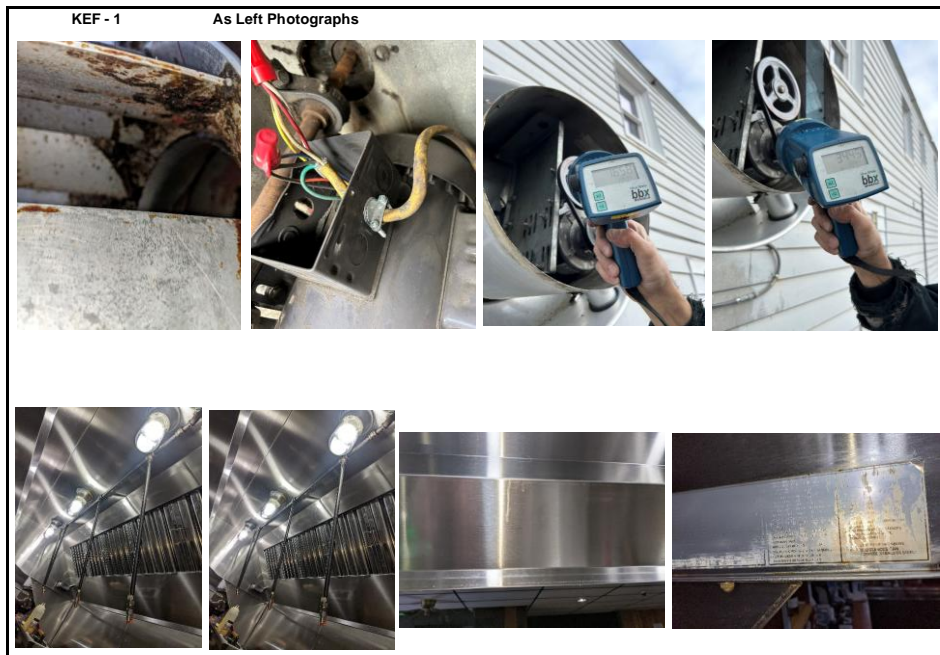
Partial Photo Log - More available upon request

- 4 Blower wheel - This contained both really old, caked-on grease and newly formed grease. We cleaned it and then slowed the unit down. Probably good for a good one (1) year but should be serviced with the cleaning of the Captive-Aire Kitchen Hood. Please see the pictures at the end for more information.

C The accessories to connect the new electric motor windings wires to the disconnects "whip" were NOT secured to through a UL Approved fastener (See "As Found" pictures) AND the incorrect wire nuts were used.
