1/7/2025  
Building Moisture Investigation at  
Elvehjem Arts Center

There are several problems at the Elvehjem Arts Center.

1. The top floor of the building, the Penthouse Mechanical Room, is annually pressurized to be slightly positive by 0.05 inches of water column.
2. Moisture condensing on the roof below the Penthouse Mechanical Room on the outside of the building.

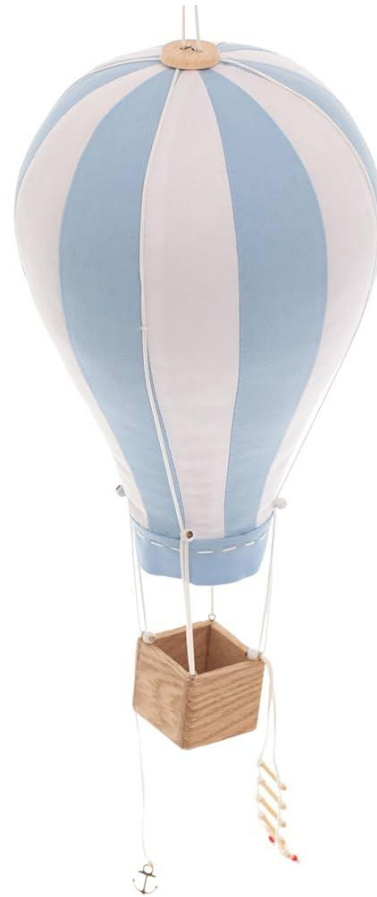
The current understanding of a hot air balloon pressures.

An excellent example of building pressure can be explained by using a simple hot air balloon and the pressures it exerts while it is inflated.

Please note that it is affected when the wind is blowing and can be viewed by simply watching the balloon's shape while it is in flight.

Positive at the top

Neutral in the middle

Negative at the bottom

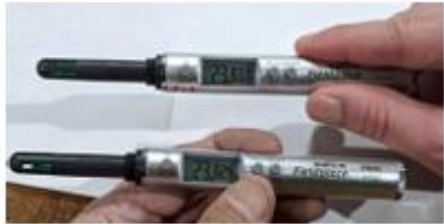
These readings were taken in the Elvehjem Arts Center, inside the Mechanical Penthouse Room, by the stairwell.

29.8	Inches of Hg	Atmospheric Pres.	No Change
<b>83.1</b>	<b>Fahrenheit</b>	<b>Dry - Bulb</b>	<b>Standard</b>
59.4	Fahrenheit	Wet - Bulb	Standard
<b>23.0</b>	<b>%</b>	<b>Relative Humidity</b>	<b>Standard</b>
<b>41.5</b>	<b>Fahrenheit</b>	<b>Dew Point</b>	<b>Standard</b>
<b>38.6</b>	<b>Grains / Lbs</b>	<b>Water Vapor Content</b>	<b>Standard</b>
26.0	Btu/lb	Enthalpy	Standard
13.80	Cu.Ft. / lbs	Specific Volume	Standard

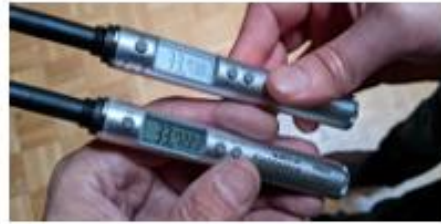
These readings were taken on the upper Artium floor, outside the stairwell and elevator.

29.8	Inches of Hg	Atmospheric Pres.	No Change
<b>73.8</b>	<b>Fahrenheit</b>	<b>Dry - Bulb</b>	<b>Standard</b>
56.4	Fahrenheit	Wet - Bulb	Standard
<b>33.0</b>	<b>%</b>	<b>Relative Humidity</b>	<b>Standard</b>
<b>43.0</b>	<b>Fahrenheit</b>	<b>Dew Point</b>	<b>Standard</b>
<b>40.8</b>	<b>Grains / Lbs</b>	<b>Water Vapor Content</b>	<b>Standard</b>
24.1	Btu/lb	Enthalpy	Standard
13.57	Cu.Ft. / lbs	Specific Volume	Standard

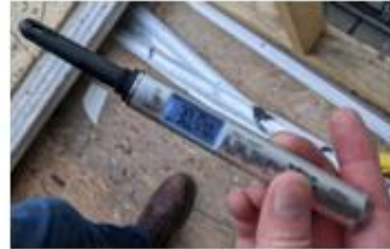
These readings were taken on the "trolley platform" located in the Mezzanine below the glass.

29.8	Inches of Hg	Atmospheric Pres.	No Change
75.9	Fahrenheit	Dry - Bulb	Standard
<b>57.0</b>	<b>Fahrenheit</b>	<b>Wet - Bulb</b>	<b>Standard</b>
<b>30.0</b>	<b>%</b>	<b>Relative Humidity</b>	<b>Standard</b>
<b>42.3</b>	<b>Fahrenheit</b>	<b>Dew Point</b>	<b>Standard</b>
<b>39.8</b>	<b>Grains / Lbs</b>	<b>Water Vapor Content</b>	<b>Standard</b>
24.4	Btu/lb	Enthalpy	Standard
13.62	Cu.Ft. / lbs	Specific Volume	Standard

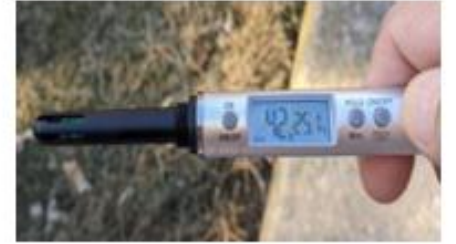
The readings from these two instruments show that the moisture content is uniform throughout the Art Center and there is very little moisture present outside. Therefore, the moisture on the roof **MUST BE COMING FROM INSIDE THE FACILITY!**

These readings were taken outside the building of the Elvehjem Arts Center.

29.8	Inches of Hg	Atmospheric Pres.	No Change
<b>25.1</b>	<b>Fahrenheit</b>	<b>Dry - Bulb</b>	<b>Standard</b>
20.5	Fahrenheit	Wet - Bulb	Standard
<b>42.0</b>	<b>%</b>	<b>Relative Humidity</b>	<b>Standard</b>
7.4	Fahrenheit	Dew Point	Standard
8.02	Grains / Lbs	Water Vapor Content	Standard
7.3	Btu/lb	Enthalpy	Standard
12.24	Cu.Ft. / lbs	Specific Volume	Standard
